8 September 2023

## General Motors Position Statement Bumper/Fascia Replacement with Advanced Driver Assistance Systems (ADAS)

### Bumper/Fascia Replacement with Advanced Driver Assistance Systems (ADAS)

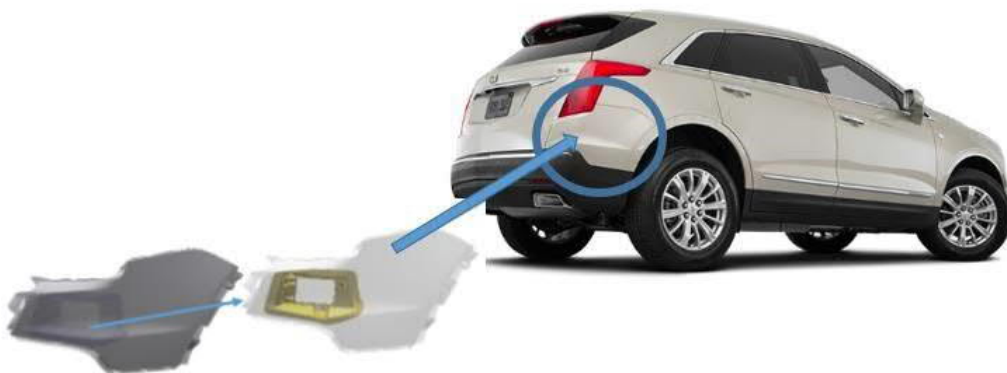
Figure 1.1

Depending on vehicle build configuration, the Bumper/Fascia system may have ADAS sensors attached to the inner surface that are not visible from the exterior of the vehicle (Please refer to Figure 1.1). GM is limiting repairs to these Bumper/Fascia systems on vehicles equipped with ADAS.
