## General Motors Position Statement Information on Proper Use of Floor Mats

## 2023 and Prior GM Passenger Cars and Light Duty Trucks

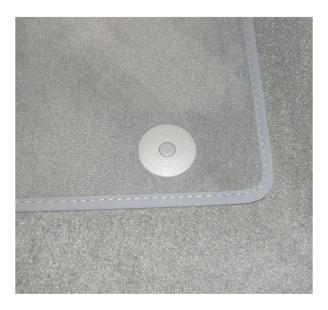
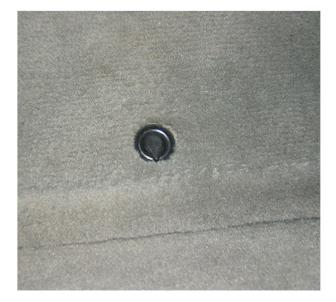
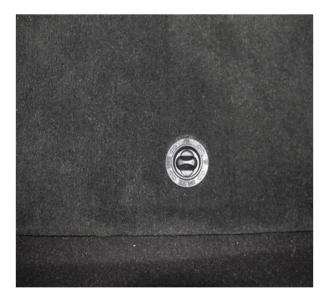
If your vehicle is equipped with a floor mat retaining button(s), hook(s) or knob(s), make certain the mat is installed correctly and according to the instructions.

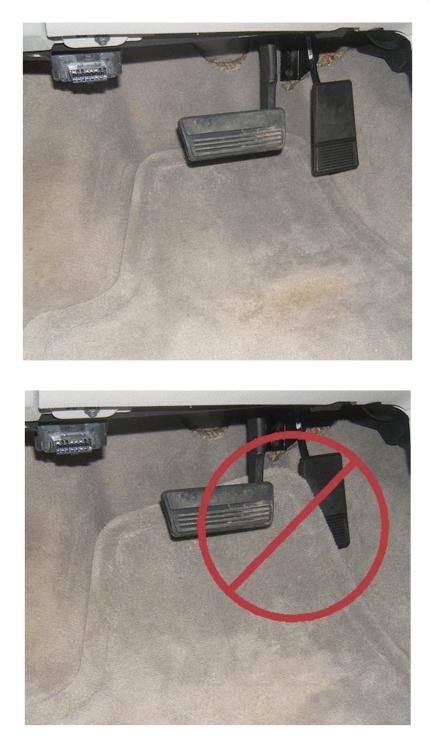
After installing floor mats, make certain they cannot move and do not interfere with the accelerator or brake pedals.
